PART 1

How to Mitigate the Most Common Collision Types and Circumstances

1.1 Collision Type 1: Bus Turning Right

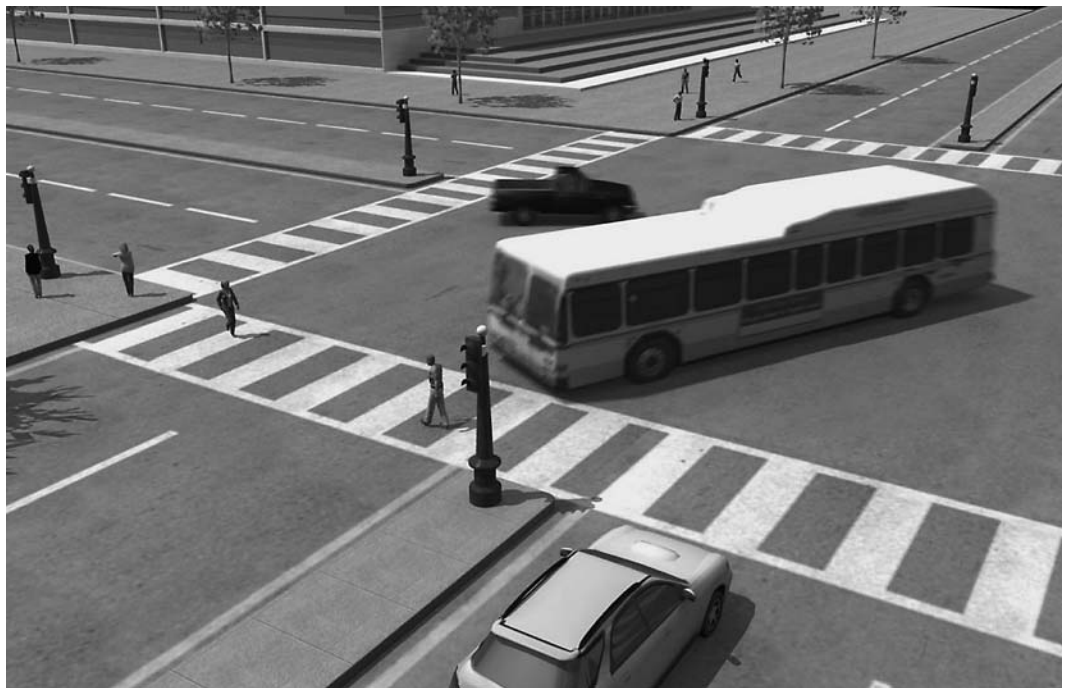
Figure 1-2. *Illustration of Collision Type 2—collision between pedestrian and left-turning bus.*

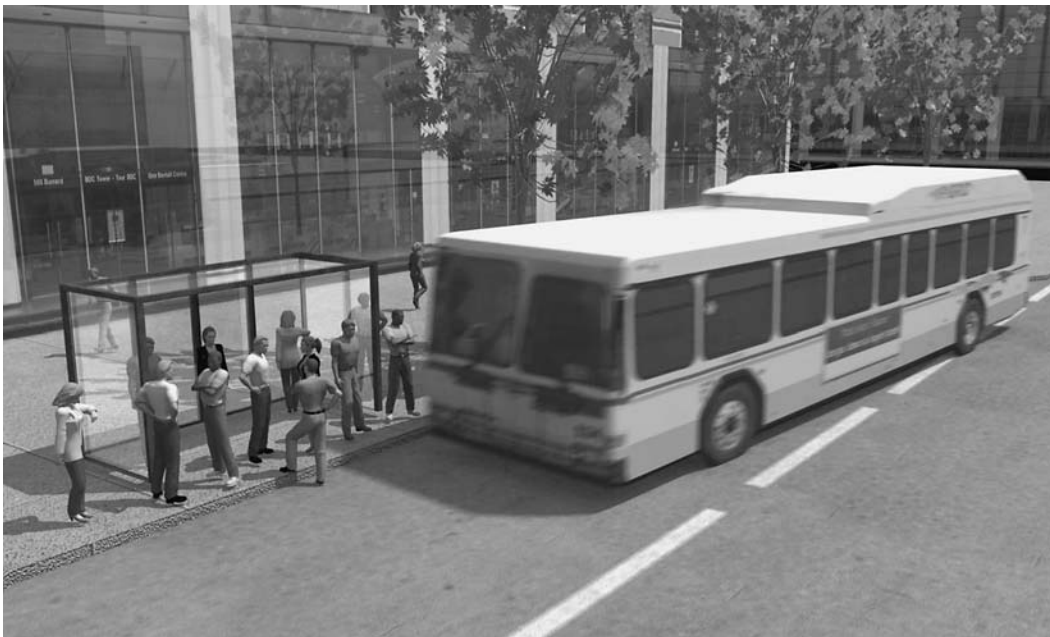
Figure 1-3. Illustration of Collision Type 3—collision between pedestrian and bus pulling into bus stop.

the bus is pulling into a bus stop, the pedestrian's location and behavior varies: he or she might be waiting at the stop, crossing the road and arriving at the stop, or walking along the road or sidewalk near the stop. Figure 1-3 illustrates an example of this collision type.

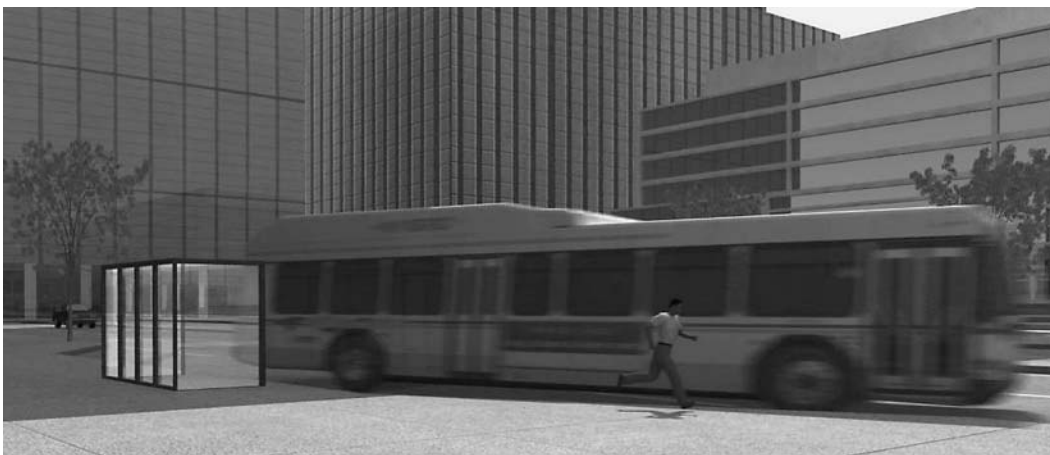
Figure 1-4. Illustration of Collision Type 4—collision with pedestrian running alongside bus when pulling away from a bus stop.

By far the most common circumstance of this collision is when a pedestrian is running after the bus after it has already pulled away from the curb and the pedestrian, who is running alongside the bus, trips and falls under the bus (Figure 1-4). However, a few stakeholders reported a variation of this collision type, which involves a pedestrian crossing the roadway in front of the bus as the bus is pulling away from the curb (Figure 1-5).
